2 CSL Data Processing and Interpretation Using 3-D Tomography

2.2 Case Studies

2.2.1 Bridge Foundation Construction Site 1

2.2.2 Bridge Foundation Construction Site 2

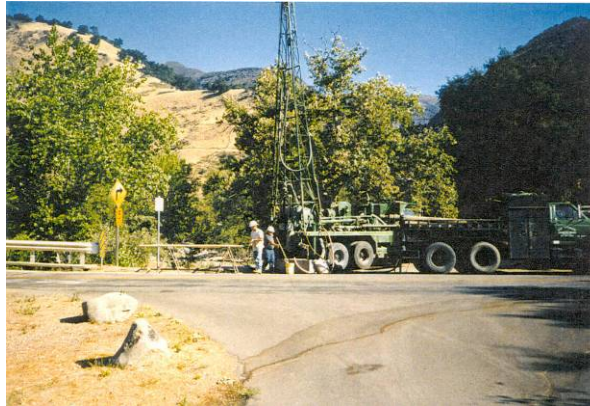
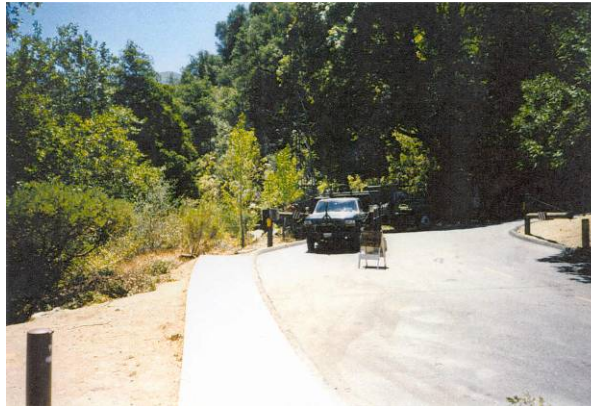
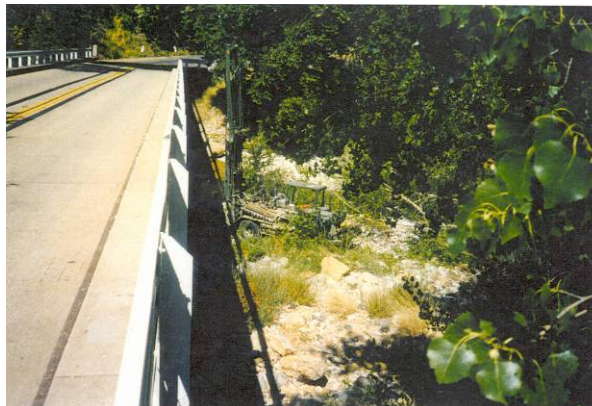
Figure 2.1 Pictures Showing Locations of (a) Boring B-5, (b) Boring B-6, and (c) Boring B-7

- Boring B-5 was advanced at the left side of the proposed abutment 2 location as shown in Figure 2.1a. This boring encountered sandy gravel with cobbles and boulders from 0 to 6.9 m deep and sandstone from 6.9 to 11.4 m deep.
- Boring B-6 was advanced at the left side of the proposed abutment 1 location as shown in Figure 2.1b. This boring encountered sandy gravel with cobbles and boulders from 0 to 4.05 m deep and sandstone from 4.05 to 8.7 m deep.

- Boring B-7 was advanced on the right side of the proposed pier location shown in Figure 2.1c. This boring encountered sandy gravel with cobbles and boulders from 0 to 1.2 m deep and sandstone from 1.2 to 6.6 m deep.

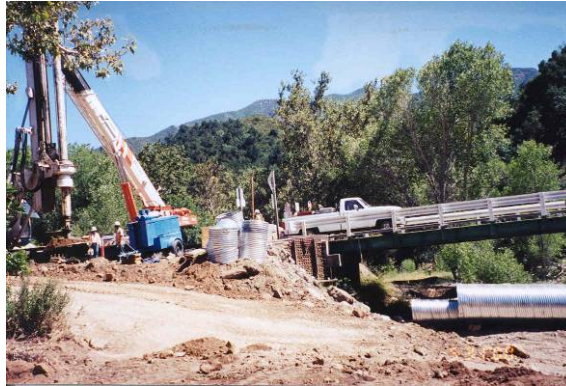
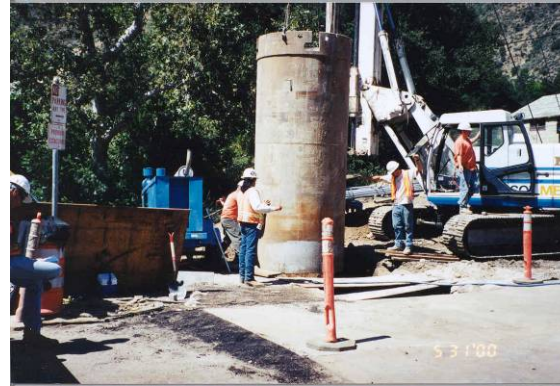
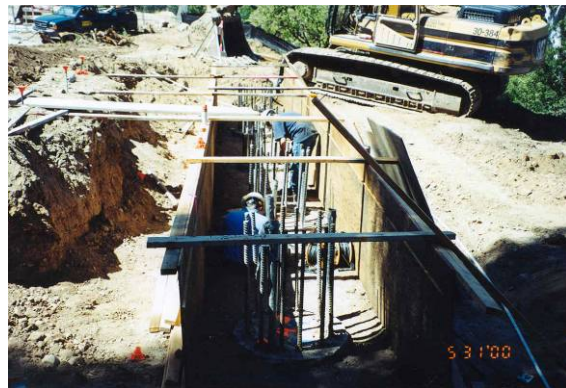
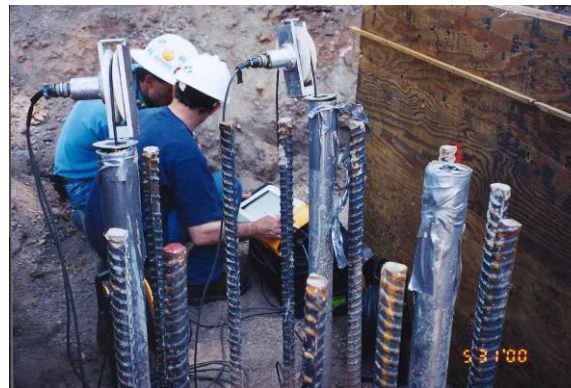
(a) Drilling Before Shaft Installation

(b) Casing Installation

(c) Abutment with four Drilled Shafts

(d) CSL Measurements

Figure 2.4 Drilled Shaft Installation and CSL Measurements

Prior to testing each shaft, the CSL access tube lengths and the horizontal spacing between the tubes (at the top of shafts) were accurately measured and recorded. Each of the three tube pair combinations (1-2, 2-3, and 1-3) was logged once with the CSL probes pulled at equal rates at the same horizon. The data (FAT) was immediately evaluated, and if a uniform data log was indicated, it was assumed that no defects existed between the tested pair, and testing proceeded to the next pair of tubes. If a significant data anomaly was depicted, the test was repeated between the same pair for reproducibility. If the time delays were still apparent, the cross-section was typically re-logged using probe vertical offsets of 0.5 m and 1.0 m. This was only necessary on shaft A1-2 (shaft number 2 in Abutment 1) for the tube pair 1-2, as will be discussed further. Shaft installation and CSL equipment setup is shown on Figure 2.4.

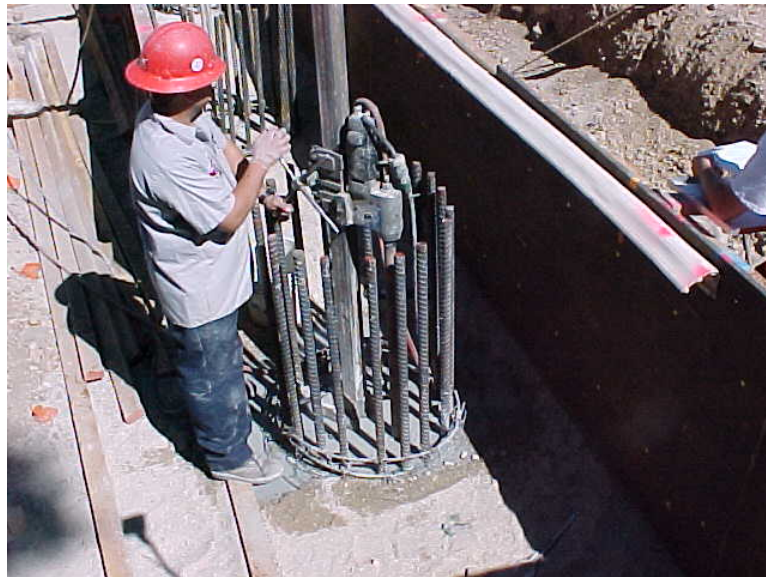
Figure 2.13 Coring Procedure of the A2-4 at Site # 2 Bridge

the middle point of the line in between tube pairs 1-3 and 2-3, as shown in Figure 2.12. The coring procedure is presented in Figure 2.13. The southeast (SE) core hole (between tube pairs 2-3) was advanced to a depth of 8.38 m and southwest (SW) (between tube pairs 1-3) was advanced to a depth of 9.14 m. At each location, extracted cores resulted in numerous mechanical fractures of the core as shown in Figure 2.14. Most of these fractures are attributed to hammering on the core barrel while extracting the core from the barrel. Since the core spins as the drill rotates, determining core orientation is not possible. The coring results were logged, and the cores were photographed.

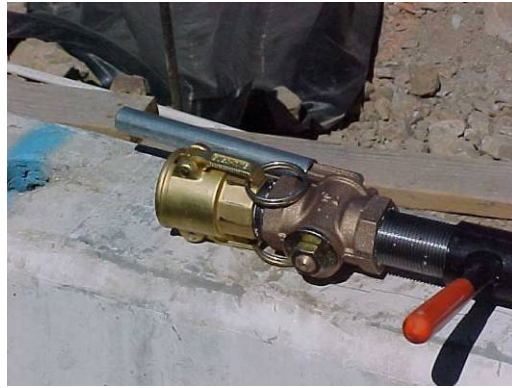
Figure 2.17 (a) & (b) Mechanism Used for Pressure Grouting

During pressure grouting, packers were installed and seated in the core hole between tubes 1-2 at a depth of a few meters above the top of the zone of deficient concrete. A pressure gage was located near the grout plant to monitor the pressure in the sealed holes. Water was injected to test the seating of the packer and to flush the sand out of the grout zone. The pressure quickly reached 3.5 MPa and was maintained for a
